MCF5407

Errata to MCF5407

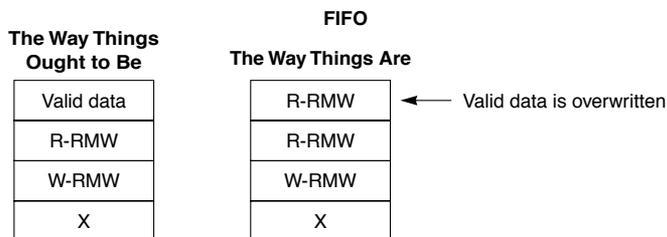
Figure 3. Read Data from Read-Modify-Write Operation Erroneously Overwrites Valid Data

If both read and write data captures are enabled, i.e., CSR[12–11] = 11, then the execution of single-cycle read-modify-write instructions result in two data operands being captured: first the read data, and then the write data. In the current design, the generation of the pipeline stall signal does not correctly account for this condition; thus depending upon the amount and sequencing of previous captures, one FIFO location can be overwritten. Thus, one incorrect data word is output from the core. The valid data that should have been output will be overwritten in the FIFO by the RMW instruction. This data will be followed by the RMW data. The read-modify-write instruction captures will be output correctly as will all subsequent instructions and data captures.

This “one incorrect PSTDDATA output” scenario can occur anytime a read-modify-write instruction occurs with only one entry in the PSTDDATA FIFO being available.

Do not enable both read and write captures; i.e. don't set CSR[12–11] = 11. Enabling read or write data captures separately functions correctly.

Another possible workaround would be to guarantee no single-cycle RMW instructions reference addresses mapped into cache or on-chip memories.
