MOTOROLA INC.

**MC68440 RS8 Mask
Errata Sheet
November, 1984**

The following is an explanation of three problems that exist on the current mask set (RS8) version of the MC68440 Dual Direct Memory Access Controller (DDMA). This mask set is available under the part number SC87876.

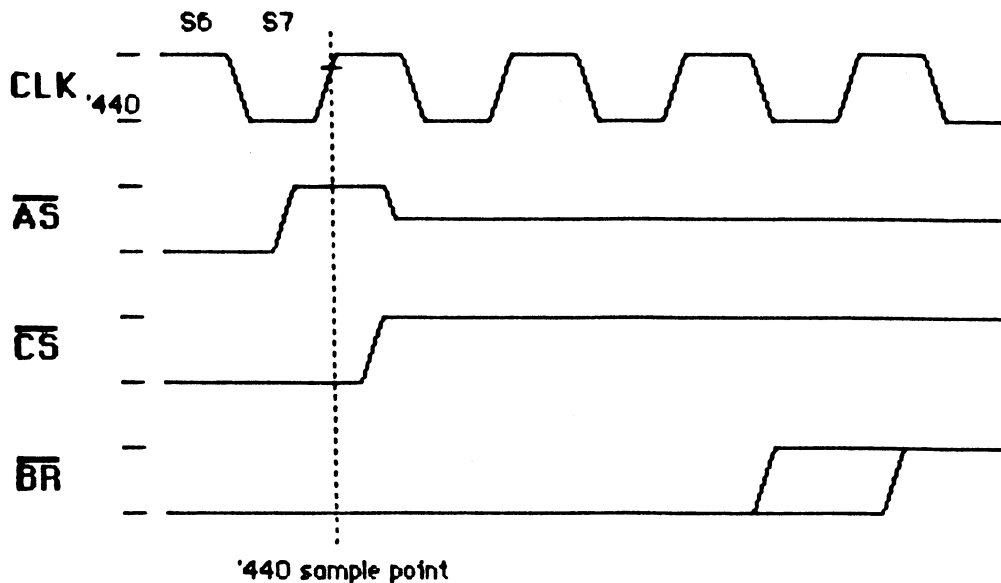
If the DDMA is being accessed in the MPU mode (either during a chip select or an interrupt acknowledge), is simultaneously requesting and has been granted the bus, and the negation of \overline{CS} or \overline{TACK} is delayed from the negation of \overline{AS} , then the channel that is causing the bus request may be aborted erroneously with an address error exception flagged in the corresponding Channel Status and Error Registers.

The signal timing that will cause this error is shown in the diagram below. The problem occurs due to the fact that the DDMA will attempt to take control of the bus as soon as it detects \overline{BG} asserted and \overline{AS} negated internally. Since \overline{CS} missed the setup time to the rising edge of the clock on which \overline{AS} negated was sampled, when the DDMA starts to service the channel that was requesting bus ownership, \overline{CS} will still be asserted internally. The DDMA reacts to this situation as though it had chip selected itself, which is defined as an Address Error for the channel being serviced.

There are several solutions to this problem that utilize the same technique; to prevent the DDMA from assuming bus mastership while \overline{CS} or \overline{IACK} is internally asserted. Some possible fixes are listed below.

- 1) Guarantee that the negation of both \overline{AS} and $\overline{CS}/\overline{IACK}$ meet the input setup time to the same rising edge of the DDMA clock; thus, when the negation of \overline{AS} and the assertion of \overline{BG} is detected internally, the internal $\overline{CS}/\overline{IACK}$ will also be negated.

- 2) Negate \overline{BG} to the DDMA while \overline{CS} or \overline{IACK} is asserted; thus forcing the DDMA to synchronize the assertion of \overline{BG} and the negation of $\overline{CS}/\overline{IACK}$ at the same time. This assumes that there will be some delay from the negation of \overline{CS} to the assertion of \overline{BG} so that the internal \overline{CS} will be negated by the time the internal \overline{BG} is asserted.

- 3) Assert the Halt bus exception code to the DDMA during \overline{CS} or \overline{IACK} cycles. This will force the DDMA to synchronize and debounce the \overline{BEC} pins before it takes control of the bus. The same effect will occur if a \overline{BEC} encoding of 5 or 6 (the undefined codes) is asserted instead of the Halt. Thus, in systems using an 'LS148 to generate the \overline{BEC} encodings, the unused 5 and 6 inputs to the 'LS148 can be tied to \overline{CS} and \overline{IACK} , respectively, for a quick and easy fix.

- 4) If an address error occurs for a channel when the MAR or DAR contains a valid address for the operation programmed into the channel, simply

clear the channel error register and restart the channel to continue the operation. This may not be feasible, since a request from a device may have been lost.

This problem will be fixed in the next mask set by forcing the DDMA to wait until \overline{AS} , \overline{CS} and \overline{TACK} are all negated before it assumes bus mastership. If any of the above fixes is implemented by external hardware, future mask versions of the DDMA will operate properly in the system.

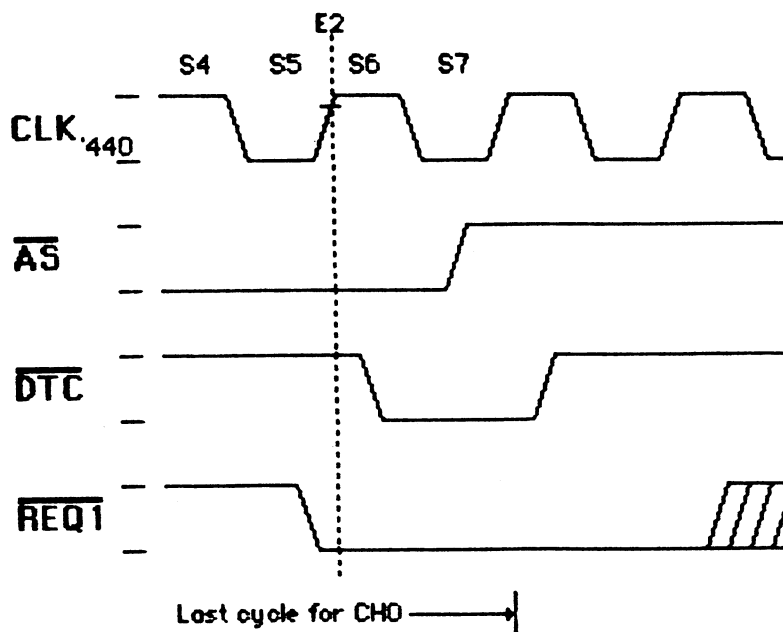
In addition to the occurrence of the conditions described above for the primary channel, if the secondary channel of the DDMA is configured for external request generation and has a "late" request, in either the burst or cycle steal mode, at a precise time, then improper operation will occur. In order to cause this error, a request for the secondary channel must not be detected until E2 (refer to page 4-27, figure 4-21 of the MC68440 Advanced Information Data Sheet, ADI-1002) of the last bus cycle executed to service the primary channel as shown below.

Now for a description of the actual failure mode. If either of the above sets of circumstances occurs, the secondary channel will be terminated incorrectly with an address error exception signalled in the CSR and CER. This is due to a speed path within the DDMA that causes the address error that is detected by the primary channel, but ignored, to be taken as an address error for the secondary channel. There are several possible fixes for this problem, as listed below.

- 1) Do not allow late requests on the secondary channel during the last bus cycle to service the primary channel. This is not feasible in asynchronous systems, but it points out the fact that this error will occur only if a late request occurs during the last cycle for the primary channel.
- 2) Do not use odd transfer counts, either in the device for configuration A, or in the MTC for configuration B. Again, this is not always feasible, particularly for data communications devices using asynchronous protocols.
- 3) When the secondary channel is terminated with an address error, simply clear the error and attempt to restart it. If the address error does not recur immediately, then it can be assumed that the primary channel conditions caused the address error. This method may not be feasible, since the request from the device for the secondary channel may have been lost.

This problem will be fixed in the next mask set.
